ASBESTOS AUDIT

REGISTER NO.: AS 2350

FOR THE PROPERTY AT: Building & Dunlevy House
Wakefield Street
Adelaide, SA

CLIENT: St Aloysius College

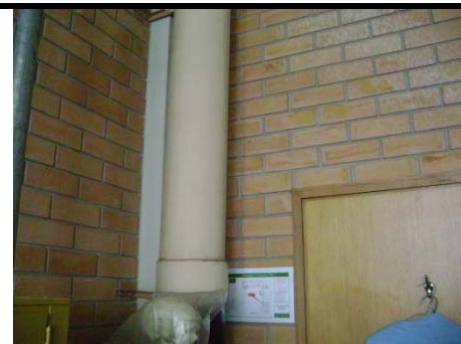
LOCATION - DESCRIPTION	EXTENT	ASBESTOS ASSESSMENT	CONDITION	SAMPLE NO VISUAL TEST	SIGNAGE STATUS
3.1b. Campion Jordan Building. Internal. Chemistry lab ground floor (now office space) and biology lab prep room, within prep / store rooms, fume cupboard flue pipe – formed or moulded fibre cement product.	Approx 4.5m long x 300mm Limited access	Presume asbestos content	Good Unsealed Non friable	Visual	Visible
SURVEY FINDINGS and HAZARD MANAGEMENT RECOMMENDATIONS					
<p>Low Risk P4 – Avoid physical and mechanical damage. When maintenance/upgrade is required, recommend removal and reinstate with non-asbestos product.</p> <p>Recommend sample (x1) to qualify material content, otherwise treat item as asbestos containing.</p> <p>January 2014 – Internal to the left of fire panel.</p>

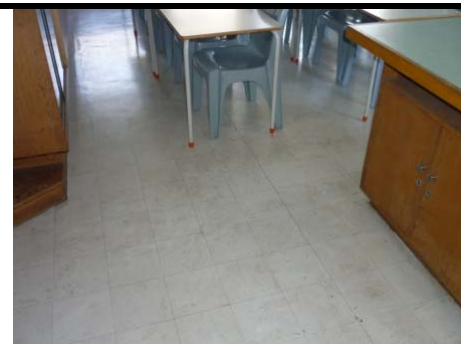
LOCATION - DESCRIPTION	EXTENT	ASBESTOS ASSESSMENT	CONDITION	SAMPLE NO VISUAL TEST	SIGNAGE STATUS
3.2a Campion Jordan Building Internal. Ground and first floor, floor covering – vinyl tiles (White tiles still exist beneath the carpet on ground floor.)	Approx 300m ² Accessible	Chrysotile asbestos detected	Good Unsealed Non friable	CJG-1(dark brown) CJG-2 (off-white) Sample No CJG-4(off-white)	Not visible.
SURVEY FINDINGS and HAZARD MANAGEMENT RECOMMENDATIONS					
<p>Low Risk P4 – Avoid physical and mechanical damage. When maintenance/upgrade is required, recommend removal and reinstate with non-asbestos product.</p> <p>Recommend install (x10) specific warning sign.</p>

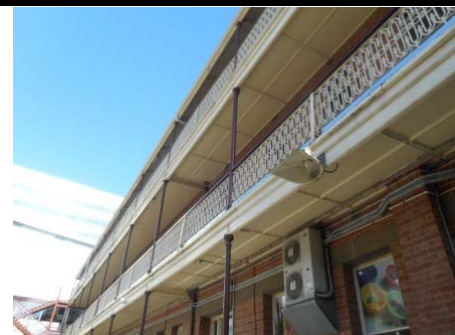
4.1a Dunlivi House. External. Part ground floor, first floor and veranda eave lining – fibre cement sheet.	Approx 60m ² Limited access	Presume asbestos content	Good Sealed Non friable	Visual	Not visible	
SURVEY FINDINGS and HAZARD MANAGEMENT RECOMMENDATIONS Low Risk P4 – Avoid physical and mechanical damage. When maintenance/upgrade is required, recommend removal and reinstate with non-asbestos product. Recommend install (x10) specific warning sign. Recommend sample (x2) to qualify material content, otherwise treat item as asbestos containing.

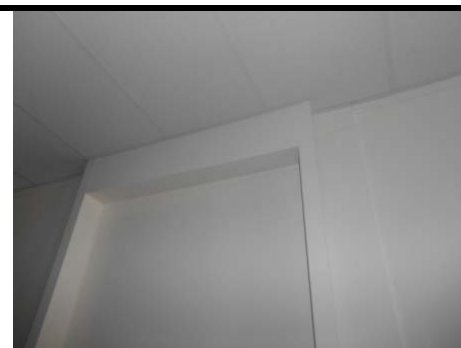
LOCATION - DESCRIPTION	EXTENT	ASBESTOS ASSESSMENT	CONDITION	SAMPLE NO VISUAL TEST	SIGNAGE STATUS
4.1b. Dunlivi House. External. Eastern box eave on second floor, lining – fibre cement sheet.	Approx 6m ² Limited access	Presume asbestos content	Not assessed	Not accessed	Not visible
SURVEY FINDINGS and HAZARD MANAGEMENT RECOMMENDATIONS					
<p>Low Risk P4 – Avoid physical and mechanical damage. When maintenance/upgrade is required, recommend removal and reinstate with non-asbestos product.</p> <p>Recommend install (x2) specific warning sign.</p> <p>Recommend sample (x1) to qualify material content, otherwise treat item as asbestos containing.</p> <p>January 2009: Item now internal in class room D201 (above closed in old entry on east wall).</p>

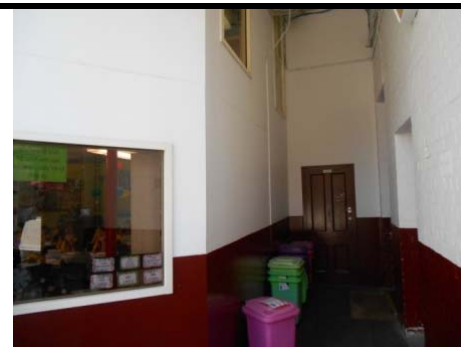
LOCATION - DESCRIPTION	EXTENT	ASBESTOS ASSESSMENT	CONDITION	SAMPLE NO VISUAL TEST	SIGNAGE STATUS
4.3. Dunlivi House. External. Convent office external wall lining – fibre cement sheet.	Approx 30m ² Accessible	Presume asbestos content	Good Sealed Non friable	Visual	Not visible
SURVEY FINDINGS and HAZARD MANAGEMENT RECOMMENDATIONS					
<p>Low Risk P4 – Avoid physical and mechanical damage. When maintenance/upgrade is required, recommend removal and reinstate with non-asbestos product.</p> <p>Recommend install (x3) specific warning sign.</p> <p>Recommend sample (x1) to qualify material content, otherwise treat item as asbestos containing.</p>

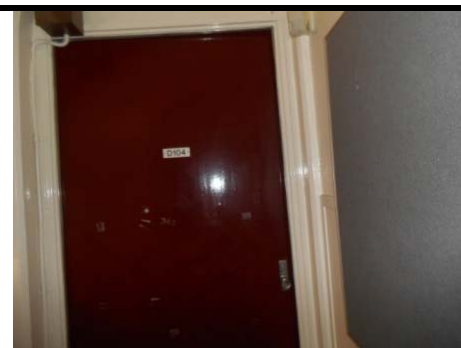
LOCATION - DESCRIPTION	EXTENT	ASBESTOS ASSESSMENT	CONDITION	SAMPLE NO VISUAL TEST	SIGNAGE STATUS
4.4. Dunlivi House. Internal. Various locations, fire door, internal core – compressed fibre insulation.	Not quantified Limited access	Presume asbestos content	Not assessed	Not accessed	Not visible
SURVEY FINDINGS and HAZARD MANAGEMENT RECOMMENDATIONS					
<p>Low Risk P4 – Avoid physical and mechanical damage. When maintenance/upgrade is required, recommend removal and reinstate with non-asbestos product.</p> <p>Treat all fire doors as having an asbestos internal core unless confirmed otherwise by sample analysis.</p>

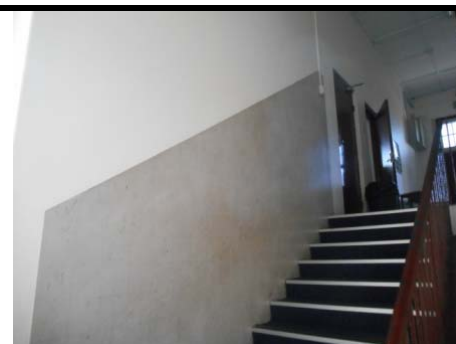
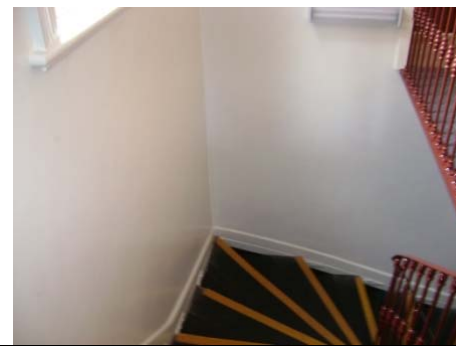
LOCATION - DESCRIPTION	EXTENT	ASBESTOS ASSESSMENT	CONDITION	SAMPLE NO VISUAL TEST	SIGNAGE STATUS
4.5 Dunlivi House. Internal. Ground, first, and second floor , wall covering at east and west stairwells – vinyl tiles	Approx 45m ² Accessible	Chrysotile asbestos detected	Good Unsealed Non friable .	Sample No MCG-1 & MCG-2	Not visible
SURVEY FINDINGS and HAZARD MANAGEMENT RECOMMENDATIONS					
<p>Low Risk P4 – Avoid physical and mechanical damage. When maintenance/upgrade is required, recommend removal and reinstate with non-asbestos product.</p> <p>Recommend install (x10) specific warning sign.</p> <p>Monitor condition. Some minor cracking in areas.</p> <p>December 2012. – Item has been removed from western stairs 2012.</p>

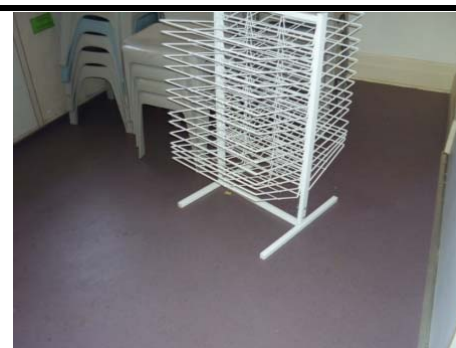
LOCATION - DESCRIPTION	EXTENT	ASBESTOS ASSESSMENT	CONDITION	SAMPLE NO VISUAL TEST	SIGNAGE STATUS
4.7. Dunlivi House. Internal. 2 nd Floor, room D202, kitchen area, floor coverings, floor covering – sheet vinyl pebble pattern beige colour).	Approx 10m ² Accessible	Chrysotile & amosite asbestos detected	Good Sealed Friable	Sample no. 01SH151209	Not visible
SURVEY FINDINGS and HAZARD MANAGEMENT RECOMMENDATIONS					
<p>Low Risk P4 – Avoid physical and mechanical damage. When maintenance/upgrade is required, recommend removal and reinstate with non-asbestos product.</p> <p>Recommend install (x2) specific warning sign.</p> <p>January 2009: Additional item.</p> <p>December 2012. – Now purplish modern vinyl, item may still exist beneath.</p>

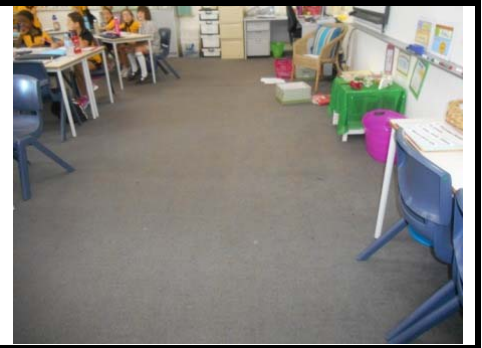
LOCATION - DESCRIPTION	EXTENT	ASBESTOS ASSESSMENT	CONDITION	SAMPLE NO VISUAL TEST	SIGNAGE STATUS
4.8. Dunlivi House. Internal. 2 nd Floor, room D203, floor covering – vinyl tiles (dark grey colour).Beneath carpet.	Approx 1m ² Limited access	Presume Asbestos Content	Not assessed	Not accessed	Not visible.
SURVEY FINDINGS and HAZARD MANAGEMENT RECOMMENDATIONS					
<p>Low Risk P4 – Avoid physical and mechanical damage. When maintenance/upgrade is required, recommend removal and reinstate with non-asbestos product.</p> <p>Recommend install (x1) specific warning sign.</p> <p>Recommend sample (x1) to qualify material content, otherwise treat item as asbestos containing.</p> <p>January 2009: Additional item. Presume to run though out building.</p>

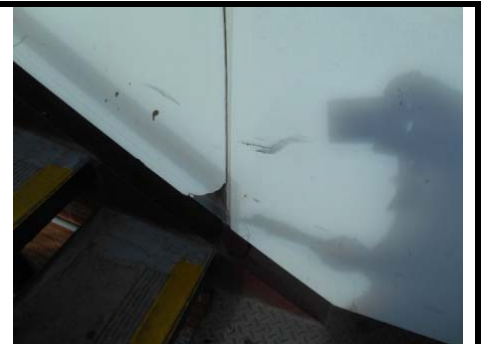
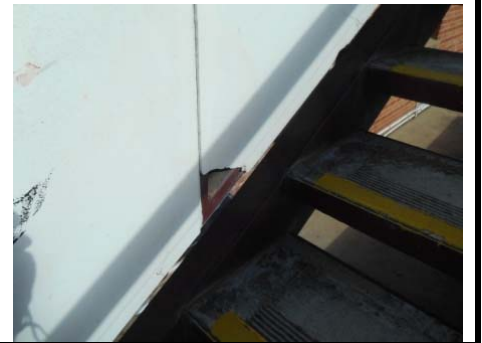
LOCATION - DESCRIPTION	EXTENT	ASBESTOS ASSESSMENT	CONDITION	SAMPLE NO VISUAL TEST	SIGNAGE STATUS
4.9 Dunlivi House External eastern stair balustrade lining (both sides) – fibre cement thick sheet.	Approx 100m ² Accessible	Chrysotile asbestos detected	Good Sealed Non friable	Similar to sample no. 26 (Oct 07) from link way balustrade	Not visible
SURVEY FINDINGS and HAZARD MANAGEMENT RECOMMENDATIONS					
<p>Low Risk P4 – Avoid physical and mechanical damage. When maintenance/upgrade is required, recommend removal and reinstate with non-asbestos product.</p> <p>Recommend install (x15) specific warning sign.</p> <p>Monitor condition. Some cracking in areas.</p> <p>December 2012. - Recommend make safe multiple broken edges between 1st. and 2nd. floors in accordance with “Asbestos Approved Code of Practice”.</p> <p>January 2014. - Previous recommendations still apply.</p>

- Item '23' – Make safe cracked sheets on kiln.
- Item 'K' – Make safe multiple cracks and broken corners.
- Item '4.9' – Make safe multiple cracks and broken corners.

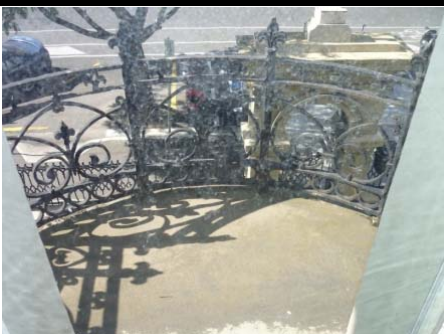
A. External. Mercy Convent building & Chapel. Angas Street balconies (x2) and the Chapel bell tower, external floor covering waterproof lining – bitumen based membrane.	Approx 20m ² Accessible	Presume asbestos content	Good Unsealed Non friable	Visual	Not visible	
SURVEY FINDINGS and HAZARD MANAGEMENT RECOMMENDATIONS Low Risk P4 – Avoid physical and mechanical damage. When maintenance/upgrade is required, recommend removal and reinstate with non-asbestos product. Recommend install (x2) specific warning sign. Recommend sample (x2) to qualify material content, otherwise treat item as asbestos containing.

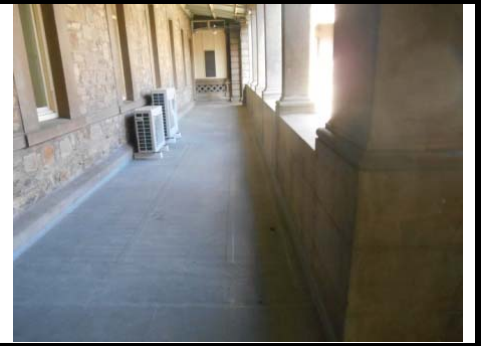
LOCATION - DESCRIPTION	EXTENT	ASBESTOS ASSESSMENT	CONDITION	SAMPLE NO VISUAL TEST	SIGNAGE STATUS
B. External. Mercy Convent building & Chapel. First floor balcony / verandah around northern courtyard and alongside Chapel, external floor covering – possible bituminous floor covering (including sub-layers).	Approx 200m ² Accessible	Presume asbestos content	Good Unsealed Non friable	Visual	Not visible
SURVEY FINDINGS and HAZARD MANAGEMENT RECOMMENDATIONS					
<p>Low Risk P4 – Avoid physical and mechanical damage. When maintenance/upgrade is required, recommend removal and reinstate with non-asbestos product.</p> <p>Recommend install (x20) specific warning sign.</p> <p>Recommend sample (x6) to qualify material content, otherwise treat item as asbestos containing.</p>

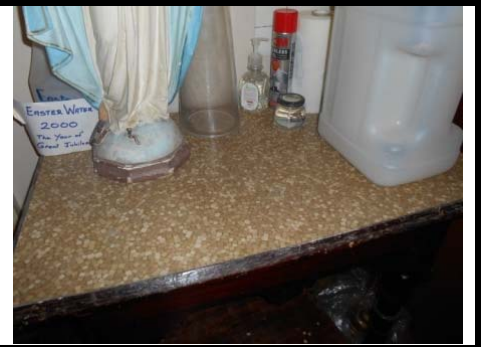
LOCATION - DESCRIPTION	EXTENT	ASBESTOS ASSESSMENT	CONDITION	SAMPLE NO VISUAL TEST	SIGNAGE STATUS
1. Internal. Mercy Convent building & Chapel. Ground floor, presentation room adjacent Chapel, table covering – sheet vinyl (cream pebble patterned lino) backing.	Approx 1m ² Accessible	Chrysotile asbestos detected	Good Sealed Friable	Sample no. 4 (Oct 07)	Not visible
SURVEY FINDINGS and HAZARD MANAGEMENT RECOMMENDATIONS					
<p>Low Risk P4 – Avoid physical and mechanical damage. When maintenance/upgrade is required, recommend removal and reinstate with non-asbestos product.</p> <p>Recommend install (x1) specific warning sign.</p>

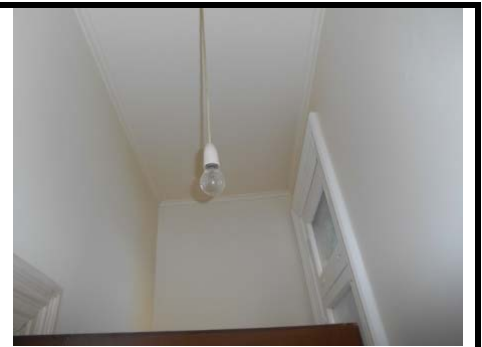
LOCATION - DESCRIPTION	EXTENT	ASBESTOS ASSESSMENT	CONDITION	SAMPLE NO VISUAL TEST	SIGNAGE STATUS
2. Internal. Mercy Convent building & Chapel. Ground floor, toilet adjacent priest sacristy (adjacent Chapel), ceiling lining – fibre cement sheet.	Approx 4m ² Limited access	Presume asbestos content	Good Sealed Non friable	Visual	Not visible
SURVEY FINDINGS and HAZARD MANAGEMENT RECOMMENDATIONS					
<p>Low Risk P4 – Avoid physical and mechanical damage. When maintenance/upgrade is required, recommend removal and reinstate with non-asbestos product.</p> <p>Recommend install (x1) specific warning sign.</p> <p>Recommend sample (x1) to qualify material content, otherwise treat item as asbestos containing.</p>

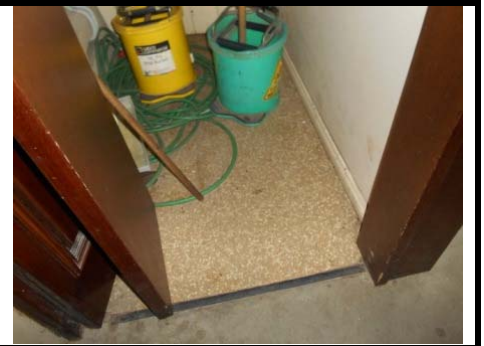
LOCATION - DESCRIPTION	EXTENT	ASBESTOS ASSESSMENT	CONDITION	SAMPLE NO VISUAL TEST	SIGNAGE STATUS
4. Internal. Mercy Convent building & Chapel. Ground floor, external central staircase, under stair store, floor covering – sheet vinyl (cream pebble patterned lino) backing.	Approx 6m ² Accessible	Chrysotile asbestos detected	Good Sealed Friable	Sample no. 7 (Oct 07)	Not visible
SURVEY FINDINGS and HAZARD MANAGEMENT RECOMMENDATIONS					
<p>Low Risk P4 – Avoid physical and mechanical damage. When maintenance/upgrade is required, recommend removal and reinstate with non-asbestos product.</p> <p>Recommend install (x1) specific warning sign.</p>

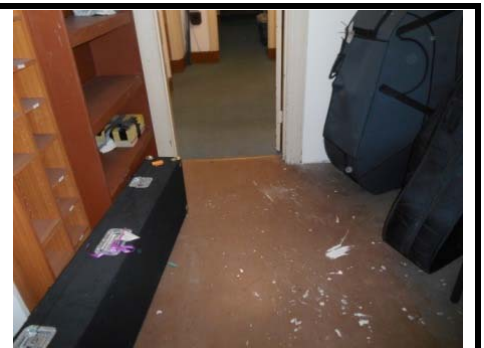
LOCATION - DESCRIPTION	EXTENT	ASBESTOS ASSESSMENT	CONDITION	SAMPLE NO VISUAL TEST	SIGNAGE STATUS
8. Internal. Mercy Convent building & Chapel. First floor, room A102, floor covering – suspect sheet vinyl (lino) backing. Beneath carpet.	Approx 8m ² Limited access	Presume asbestos content	Not assessed	Not accessed	Not visible
SURVEY FINDINGS and HAZARD MANAGEMENT RECOMMENDATIONS					
<p>Low Risk P4 – Avoid physical and mechanical damage. When maintenance/upgrade is required, recommend removal and reinstate with non-asbestos product.</p> <p>Recommend install (x4) specific warning sign. Around skirting.</p> <p>No access to this room / item. Treat as asbestos containing until qualified by inspection. Access with caution. Under masonite boarding.</p> <p>January 2014 – Room A102 is Music store, no vinyl visible, possibly beneath masonite as the carpet has been removed.</p>

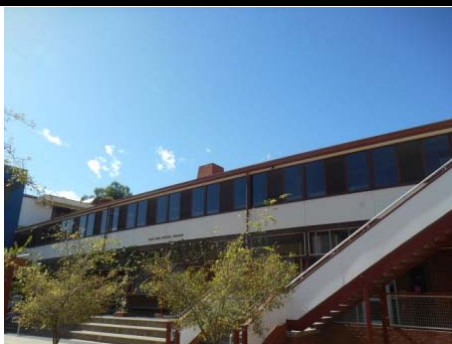
LOCATION - DESCRIPTION	EXTENT	ASBESTOS ASSESSMENT	CONDITION	SAMPLE NO VISUAL TEST	SIGNAGE STATUS
D. External. Dame Roma Mitchell Building including linked overhead walkway. First floor, north verandah, external/internal infill wall lining below window – fibre cement sheet (same item referred to internally, item 15).	Approx 100m ² Accessible	Chrysotile asbestos detected	Good Sealed Non friable	Sample no.'s 18 & 19 (Oct 07)	Not visible
SURVEY FINDINGS and HAZARD MANAGEMENT RECOMMENDATIONS					
<p>Low Risk P4 – Avoid physical and mechanical damage. When maintenance/upgrade is required, recommend removal and reinstate with non-asbestos product.</p> <p>Recommend install (x10) specific warning sign.</p> <p>October 2007: Sample no. 18 was deemed non-asbestos by laboratory analysis however this piece is assumed to be from a repaired section of lining. The remaining linings were indicative of sample no. 19 which was Chrysotile asbestos. Treat all as asbestos containing.</p>

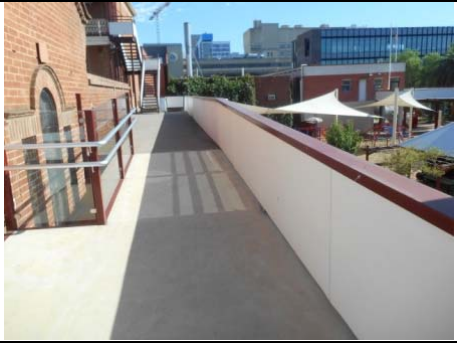
LOCATION - DESCRIPTION	EXTENT	ASBESTOS ASSESSMENT	CONDITION	SAMPLE NO VISUAL TEST	SIGNAGE STATUS
E. External. Dame Roma Mitchell Building including linked overhead walkway. Overhead link way / walkway to Dunlevy Building, balustrade lining (both sides) – fibre cement thick sheet.	Approx 100m ² Accessible	Chrysotile asbestos detected	Good Sealed Non friable	Sample no. 26 (Oct 07)	Not visible
<p>SURVEY FINDINGS and HAZARD MANAGEMENT RECOMMENDATIONS</p> <p>Low Risk P4 – Avoid physical and mechanical damage. When maintenance/upgrade is required, recommend removal and reinstate with non-asbestos product. Recommend install (x10) specific warning sign.</p> <p>December 2011: 5 sheets replaced No record of removal available. Recommend gather any asbestos removal or maintenance information and include/document this into the work/access section of the register to gain compliance. Information to include air monitoring results and where applicable statutory government approvals.</p>

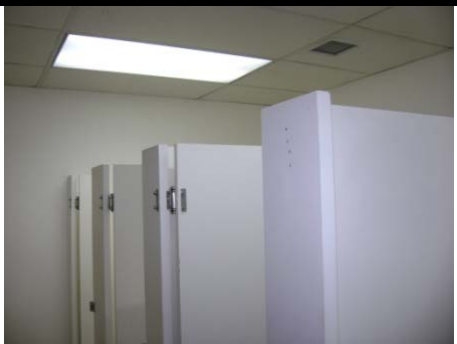
LOCATION - DESCRIPTION	EXTENT	ASBESTOS ASSESSMENT	CONDITION	SAMPLE NO VISUAL TEST	SIGNAGE STATUS
12. Internal. Dame Roma Mitchell Building Ground floor, 2 x toilet areas either side of reception, toilet partitions – fibre cement thick sheet.	Approx 16m ² Accessible	Presume asbestos content	-	Visual	-
<p>SURVEY FINDINGS and HAZARD MANAGEMENT RECOMMENDATIONS</p> <p>No Inspection - Item has been removed during major refurbishment of building, prior to audit. No record of removal available. Recommend gather any asbestos removal or maintenance information and include/document this into the work/access section of the register to gain compliance. Information to include air monitoring results and where applicable statutory government approvals.</p>

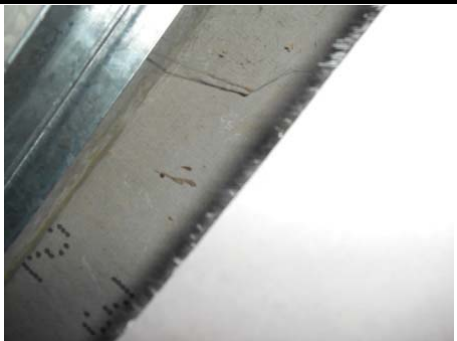
14. Internal. Dame Roma Mitchell Building Ground floor, southwest classroom M7, south west corner above openings in ceiling space, vertical infill linings – fibre cement sheet. (Above window.)	Approx 2m ² Limited access	Presume asbestos content	Good Unsealed Non friable	Visual	Not visible
<p>SURVEY FINDINGS and HAZARD MANAGEMENT RECOMMENDATIONS</p> <p>Low Risk P4 – Avoid physical and mechanical damage. When maintenance/upgrade is required, recommend removal and reinstate with non-asbestos product.</p> <p>Recommend install (x1) specific warning sign.</p> <p>Recommend sample (x1) to qualify material content, otherwise treat item as asbestos containing.</p> <p>January 2014 – New dropped ceiling has been installed, item still exists above.</p>

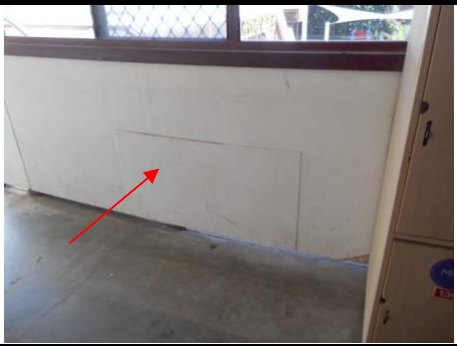
LOCATION - DESCRIPTION	EXTENT	ASBESTOS ASSESSMENT	CONDITION	SAMPLE NO VISUAL TEST	SIGNAGE STATUS
15. Internal. Dame Roma Mitchell Building First floor, enclosed north verandah, external/internal infill wall lining below window – fibre cement sheet (same item referred to externally, item D).	Approx 100m ² Accessible	Chrysotile asbestos detected	Good Sealed Non friable	Sample no.'s 18 & 19	Not visible
SURVEY FINDINGS and HAZARD MANAGEMENT RECOMMENDATIONS					
<p>Low Risk P4 – Avoid physical and mechanical damage. When maintenance/upgrade is required, recommend removal and reinstate with non-asbestos product.</p> <p>Recommend install (x10) specific warning sign.</p> <p>December 2012. - Recommend make safe 1.5 meter crack western end in accordance with “Asbestos Approved Code of Practice”.</p> <p>January 2014 – Repaired by others.</p>

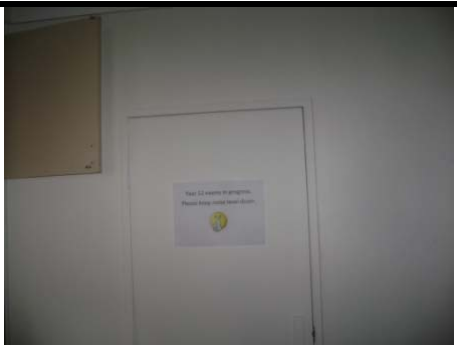
17 Internal. Dame Roma Mitchell Building. First floor, M102 classroom, internal door to M106, fire door, internal core – compressed fibre insulation.	Not quantified Limited access	Presume asbestos content	-	Visual	-
SURVEY FINDINGS and HAZARD MANAGEMENT RECOMMENDATIONS					
<p>No Inspection - Item has been removed during major refurbishment of building, prior to audit. No record of removal available.</p> <p>Recommend gather any asbestos removal or maintenance information and include/document this into the work/access section of the register to gain compliance. Information to include air monitoring results and where applicable statutory government approvals.</p>

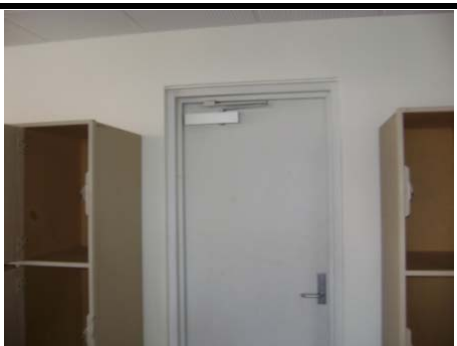
LOCATION - DESCRIPTION	EXTENT	ASBESTOS ASSESSMENT	CONDITION	SAMPLE NO VISUAL TEST	SIGNAGE STATUS
18 Internal. Dame Roma Mitchell Building. First floor, M104 classroom, internal door to M107, fire door, internal core – compressed fibre insulation.	Not quantified Limited access	Presume asbestos content	-	Visual	-

SURVEY FINDINGS and HAZARD MANAGEMENT RECOMMENDATIONS					
<p>No Inspection - Item has been removed during major refurbishment of building, prior to audit. No record of removal available.</p> <p>Recommend gather any asbestos removal or maintenance information and include/document this into the work/access section of the register to gain compliance. Information to include air monitoring results and where applicable statutory government approvals.</p>

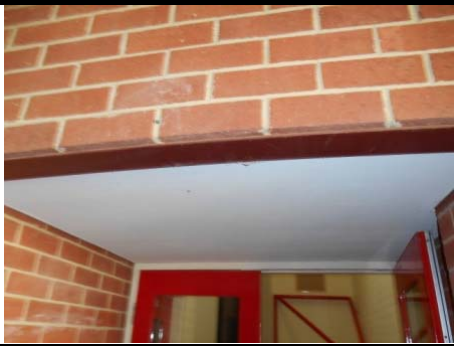
LOCATION - DESCRIPTION	EXTENT	ASBESTOS ASSESSMENT	CONDITION	SAMPLE NO VISUAL TEST	SIGNAGE STATUS	
F. External. Expressive Arts building. Ground floor, lobby entrance at north west corner, porch lining – fibre cement sheet.	Approx 2m ² Limited access	Presume asbestos content	Good Sealed Non friable	Visual	Not visible

SURVEY FINDINGS and HAZARD MANAGEMENT RECOMMENDATIONS						
<p>Low Risk P4 – Avoid physical and mechanical damage. When maintenance/upgrade is required, recommend removal and reinstate with non-asbestos product.</p> <p>Recommend install (x1) specific warning sign.</p> <p>Recommend sample (x1) to qualify material content, otherwise treat item as asbestos containing.</p>

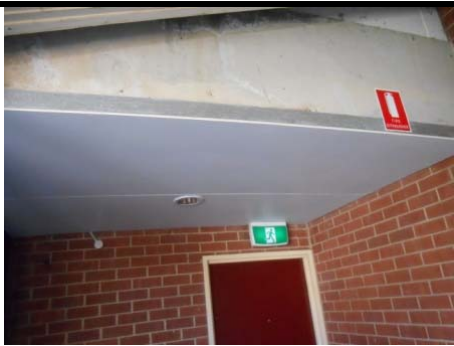
G. External. Expressive Arts building. First floor, northwest porch / lobby area, porch ceiling lining – fibre cement sheet.	Approx 4m ² Limited access	Presume asbestos content	Good Sealed Non friable	Visual	Not visible

SURVEY FINDINGS and HAZARD MANAGEMENT RECOMMENDATIONS						
<p>Low Risk P4 – Avoid physical and mechanical damage. When maintenance/upgrade is required, recommend removal and reinstate with non-asbestos product.</p> <p>Recommend install (x1) specific warning sign.</p> <p>Recommend sample (x1) to qualify material content, otherwise treat item as asbestos containing.</p>

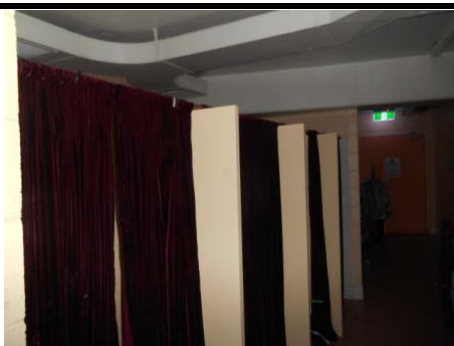
20. Internal. Expressive Arts building. Basement, change rooms, shower partitions – fibre cement thick sheet.	Approx 12m ² Accessible	Presume asbestos content	Good Sealed Non friable	Visual	Not visible

SURVEY FINDINGS and HAZARD MANAGEMENT RECOMMENDATIONS						
<p>Low Risk P4 – Avoid physical and mechanical damage. When maintenance/upgrade is required, recommend removal and reinstate with non-asbestos product.</p> <p>Recommend install (x6) specific warning sign.</p> <p>Recommend sample (x1) to qualify material content, otherwise treat item as asbestos containing.</p>

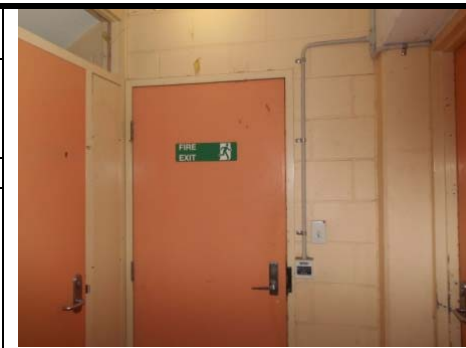
LOCATION - DESCRIPTION	EXTENT	ASBESTOS ASSESSMENT	CONDITION	SAMPLE NO VISUAL TEST	SIGNAGE STATUS
21. Internal. Expressive Arts building. Stairwells, fire doors, internal core – compressed fibre insulation.	Not quantified Limited access	Presume asbestos content	Not assessed	Not accessed	Not visible
SURVEY FINDINGS and HAZARD MANAGEMENT RECOMMENDATIONS					
<p>Low Risk P4 – Avoid physical and mechanical damage. When maintenance/upgrade is required, recommend removal and reinstate with non-asbestos product.</p> <p>Recommend install (x6) specific warning sign. Treat all fire doors as having an asbestos internal core unless confirmed otherwise by sample analysis.</p>

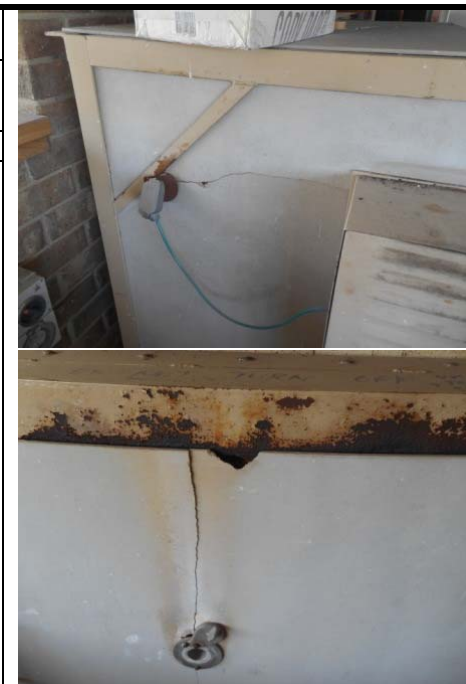
LOCATION - DESCRIPTION	EXTENT	ASBESTOS ASSESSMENT	CONDITION	SAMPLE NO VISUAL TEST	SIGNAGE STATUS
23. Internal. Expressive Arts building. Second floor, Pottery Area, "Ridgeway" small kiln, external lining to kiln – fibre cement sheet.	Approx 3m ² Accessible	Chrysotile & amosite asbestos detected	Moderate Unsealed Non friable	Sample no. 14 (Oct 07)	Not visible
SURVEY FINDINGS and HAZARD MANAGEMENT RECOMMENDATIONS					
<p>Low Risk P4 – Avoid physical and mechanical damage. When maintenance/upgrade is required, recommend removal and reinstate with non-asbestos product.</p> <p>Recommend install (x6) specific warning sign. Monitor condition. Slight cracking visible. Recommend planned removal in accordance with "Asbestos Approved Code of Practice".</p> <p>December 2012. - Recommend removal in accordance with "Asbestos Approved Code of Practice". As interim Recommend make safe cracks on all sides and top of item in accordance with "Asbestos Approved Code of Practice".</p> <p>January 2014 - Previous recommendations still apply.</p>

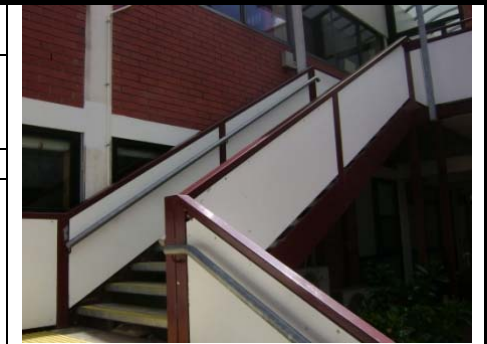
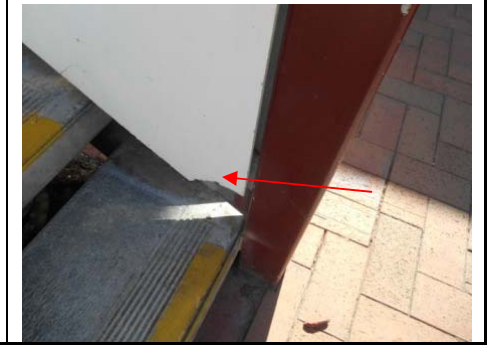
LOCATION - DESCRIPTION	EXTENT	ASBESTOS ASSESSMENT	CONDITION	SAMPLE NO VISUAL TEST	SIGNAGE STATUS
K. External McAuley Centre & Auditorium. South stairway to first floor auditorium, balustrade panels (both sides of rail) – fibre cement thick sheet.	Approx 60m ² Accessible	Presume asbestos content	Good Sealed Non friable	Visual	Not visible

Low Risk P4 – Avoid physical and mechanical damage. When maintenance/upgrade is required, recommend removal and reinstate with non-asbestos product.

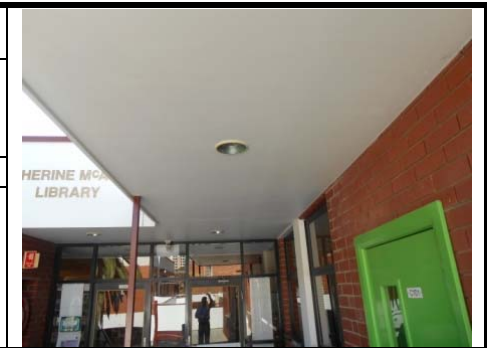
LOCATION - DESCRIPTION	EXTENT	ASBESTOS ASSESSMENT	CONDITION	SAMPLE NO VISUAL TEST	SIGNAGE STATUS
L. External McAuley Centre & Auditorium Front entry verandah to library at first level, verandah lining – fibre cement sheet.	Approx 15m ² Limited access	Presume asbestos content	Good Sealed Non friable	Visual	Not visible

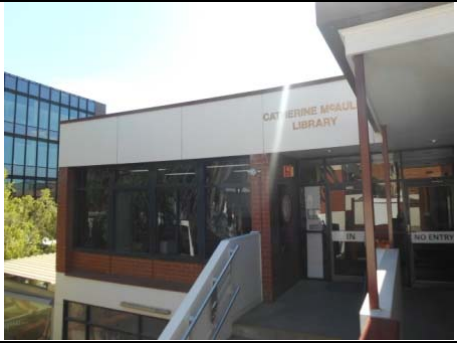
LOCATION - DESCRIPTION	EXTENT	ASBESTOS ASSESSMENT	CONDITION	SAMPLE NO VISUAL TEST	SIGNAGE STATUS	
M. External McAuley Centre & Auditorium North side of building, roof level facades – fibre cement thick sheet.	Approx 40m ² Limited access	Presume asbestos content	Good Sealed Non friable	Visual	Not visible

<p>SURVEY FINDINGS and HAZARD MANAGEMENT RECOMMENDATIONS</p> <p>Low Risk P4 – Avoid physical and mechanical damage. When maintenance/upgrade is required, recommend removal and reinstate with non-asbestos product. Recommend install (x3) specific warning sign. Recommend sample (x2) to qualify material content, otherwise treat item as asbestos containing. Monitor condition. Some cracking in corners.</p>

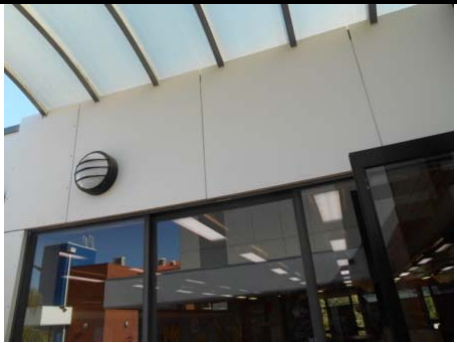
N. External McAuley Centre & Auditorium. South side of library (above external stair landing), facade lining over windows – fibre cement thick sheet.	Approx 8m ² Limited access	Presume asbestos content	Good Sealed Non friable	Visual	Not visible

<p>SURVEY FINDINGS and HAZARD MANAGEMENT RECOMMENDATIONS</p> <p>Low Risk P4 – Avoid physical and mechanical damage. When maintenance/upgrade is required, recommend removal and reinstate with non-asbestos product. Recommend install (x3) specific warning sign. Recommend sample (x2) to qualify material content, otherwise treat item as asbestos containing.</p>

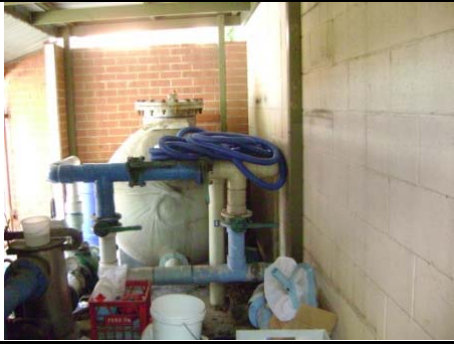
LOCATION - DESCRIPTION	EXTENT	ASBESTOS ASSESSMENT	CONDITION	SAMPLE NO VISUAL TEST	SIGNAGE STATUS
O. Internal. General Site (Including Pool Area). . Pool pump shed, general pipe gaskets – compressed fibre material.	Not quantified Limited access	Presume asbestos content	Not assessed	Not accessed	Not visible
SURVEY FINDINGS and HAZARD MANAGEMENT RECOMMENDATIONS					
<p>Low Risk P4 – Avoid physical and mechanical damage. When maintenance/upgrade is required, recommend removal and reinstate with non-asbestos product.</p> <p>Recommend install (x1) specific warning sign.</p> <p>Treat all gaskets (other than rubber or cork) as asbestos containing unless confirmed otherwise by sample analysis.</p>

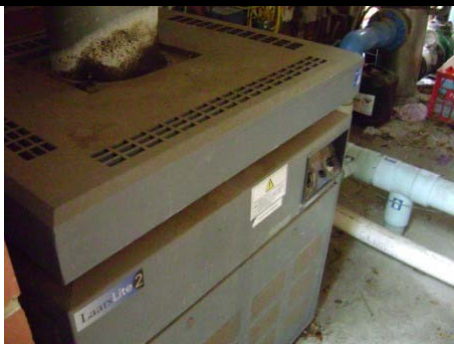
P. Internal. Pool pump shed, "Laars" boiler– possible door seals, gaskets, insulation blocks, heat shield & lining.	Not quantified Limited access	Presume asbestos content	Not assessed	Not accessed	Not visible
SURVEY FINDINGS and HAZARD MANAGEMENT RECOMMENDATIONS					
<p>Low Risk P4 – Avoid physical and mechanical damage. When maintenance/upgrade is required, recommend removal and reinstate with non-asbestos product.</p> <p>Recommend install (x1) specific warning sign.</p> <p>Treat all gaskets (other than rubber or cork) as asbestos containing unless confirmed otherwise by sample analysis.</p>
